Pest & Building Report

1-45 Johns Road Lonely

Sample 2 Storey Duplex

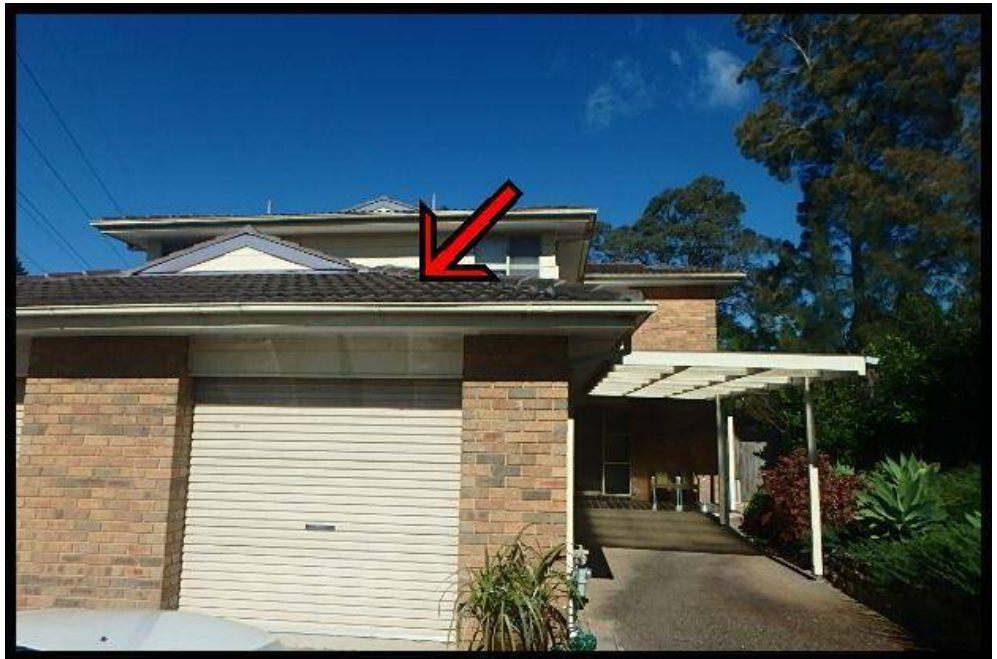
Roof Covering Condition in Detail:

The overall condition of the roof coverings is fair. The surface of the concrete tiles is deteriorating and the area requires sealing.

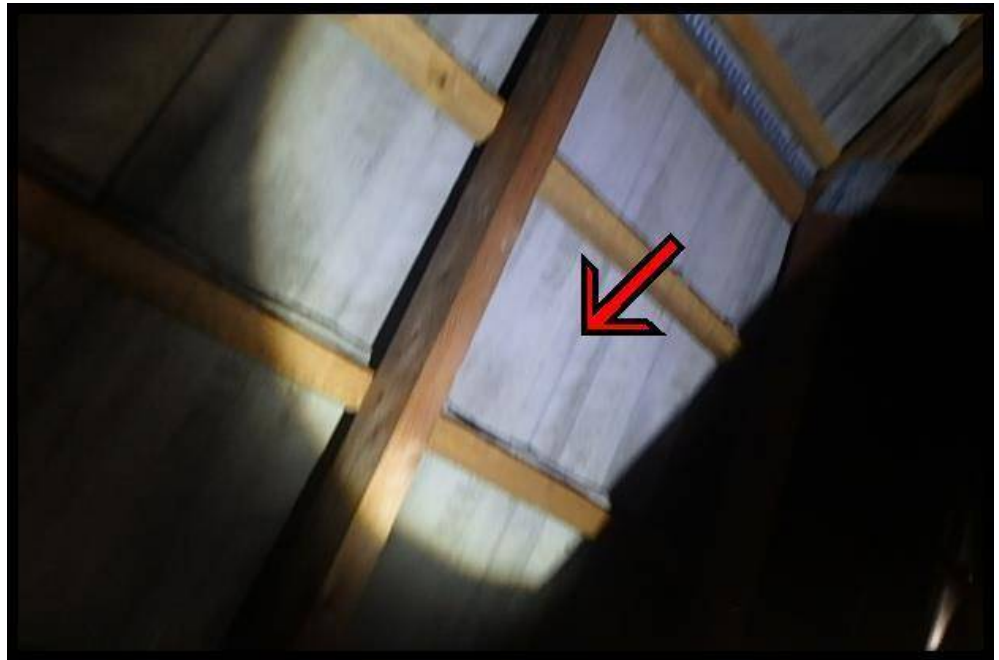
Sarking Status:

There is no sarking membrane present in the roof area.

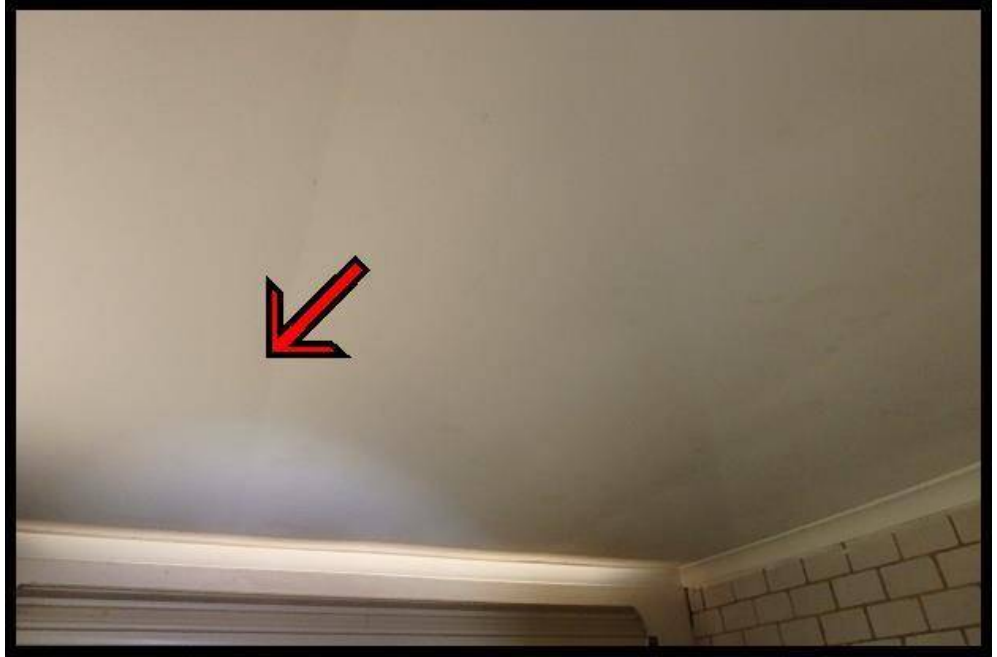
Ceiling Condition:

The condition of the ceilings is generally fair. Some minor blemishes were present on the ceiling linings. Minor undulations were noted to the ceiling lining. This is to be expected in a house of this age. Periodic maintenance may be required.

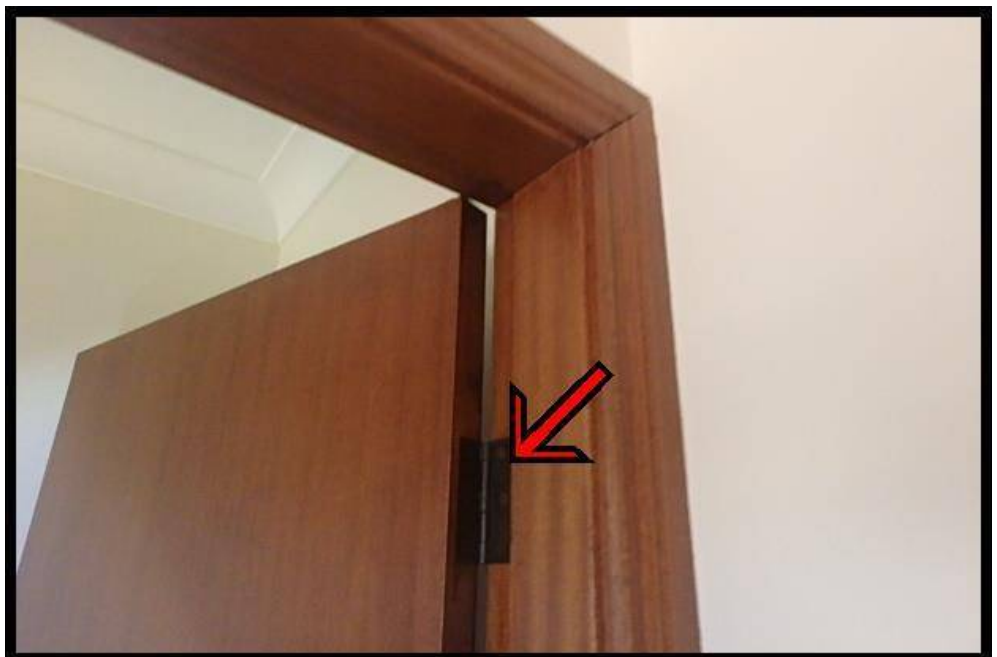
Doors Condition:

Wear & tear was noted to some doors. The toilet door swings inwards and is restrictive to the toilet area.

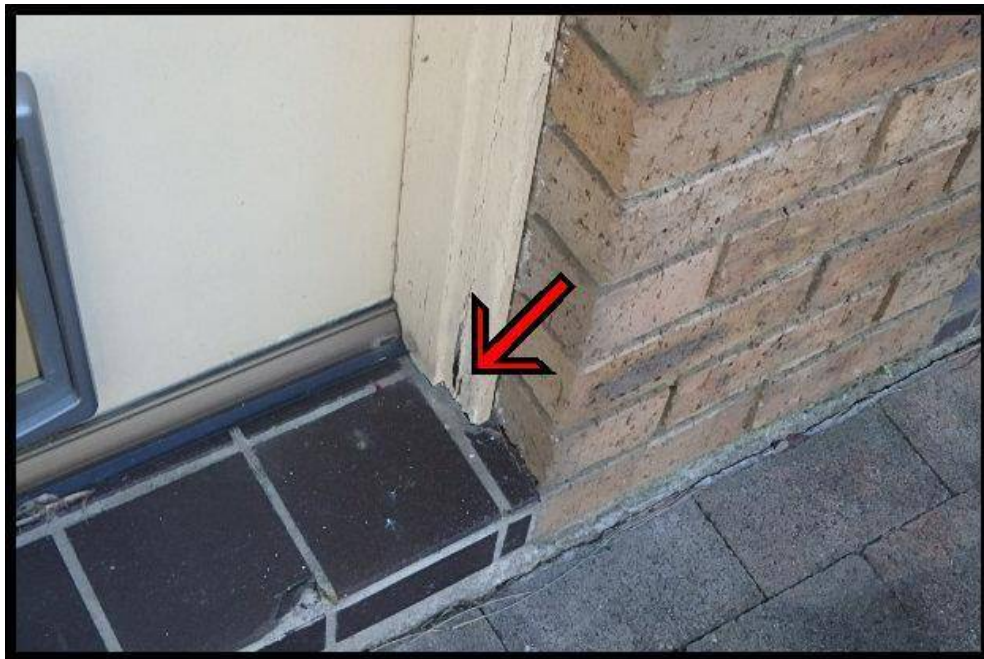
Woodwork

The condition of the woodwork is generally fair. Wet rot decay damage was noted to the door jamb. Any damage will require maintenance, repair or replacement.

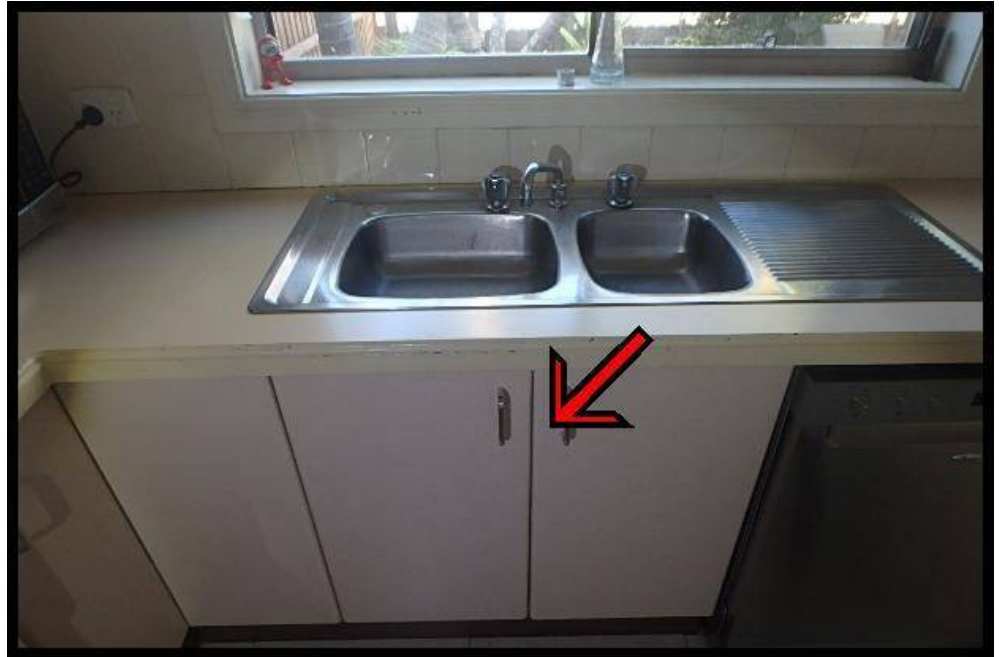
Kitchen Fixtures:

The condition of the fixtures is generally good. Wear and tear is noted to cabinets and/or doors and some maintenance or repairs will be required.

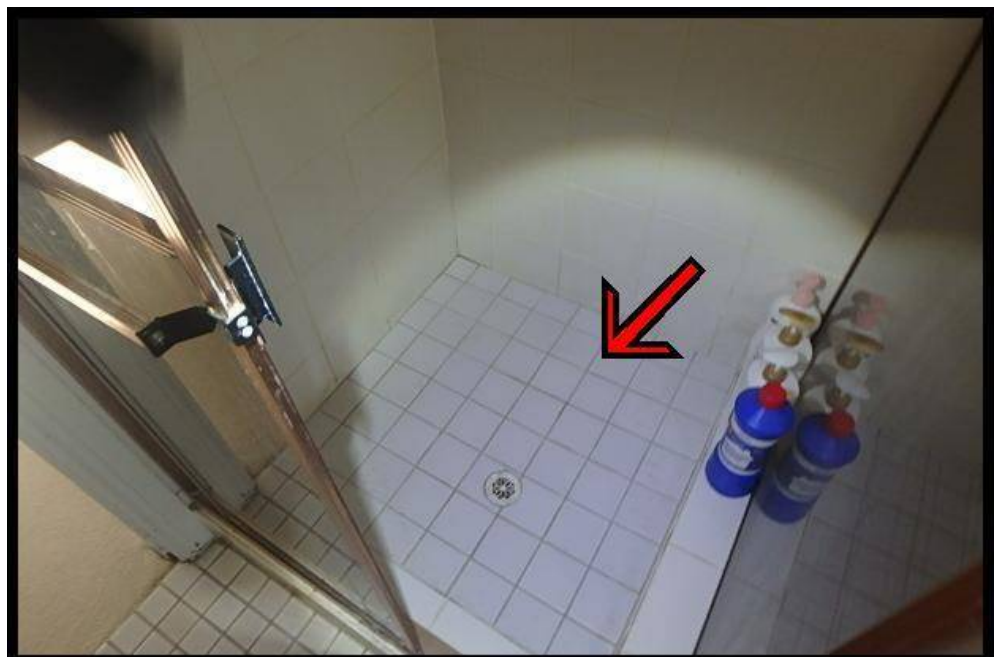
Shower/Bath Condition:

The shower recess was tested and there was no visible water penetration to surrounding areas. The waterproofing on the shower is out of warranty and we recommend the purchaser contact a shower waterproofing company to advise on

further waterproofing & extended warranty options. **IMPORTANT NOTE:** This test may not reveal water leaks until the shower is put into constant use and surrounding areas monitored over a period of time.

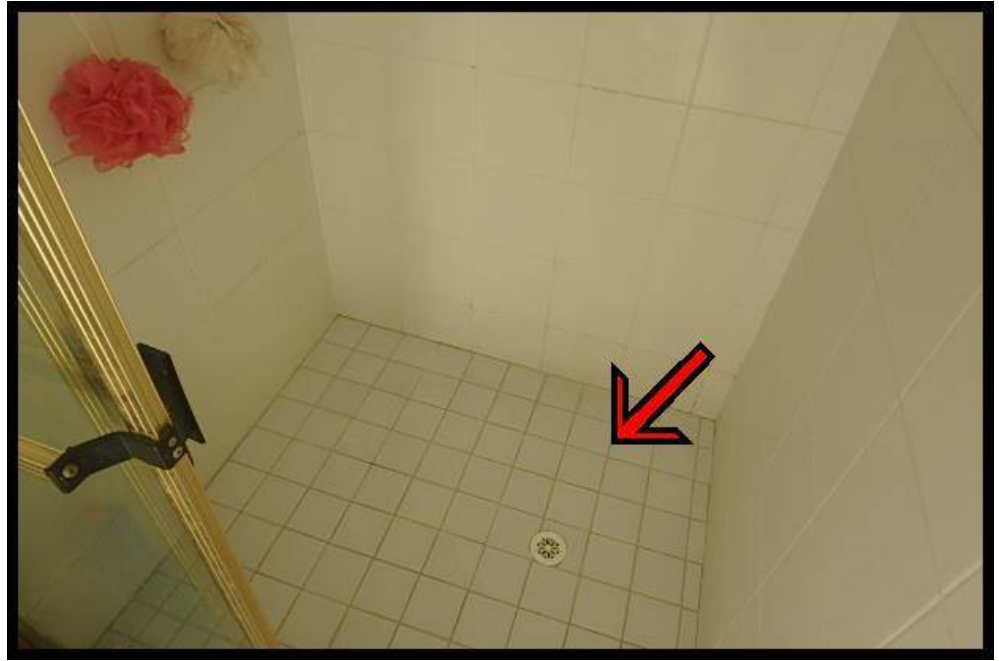
Shower/Bath Condition:

The shower recess was tested and there was no visible water penetration to surrounding areas. The waterproofing on the shower is out of warranty and we recommend the purchaser contact a shower waterproofing company to advise on further waterproofing & extended warranty options. **IMPORTANT NOTE:** This test may not reveal water leaks until the shower is put into constant use and surrounding areas monitored over a period of time.

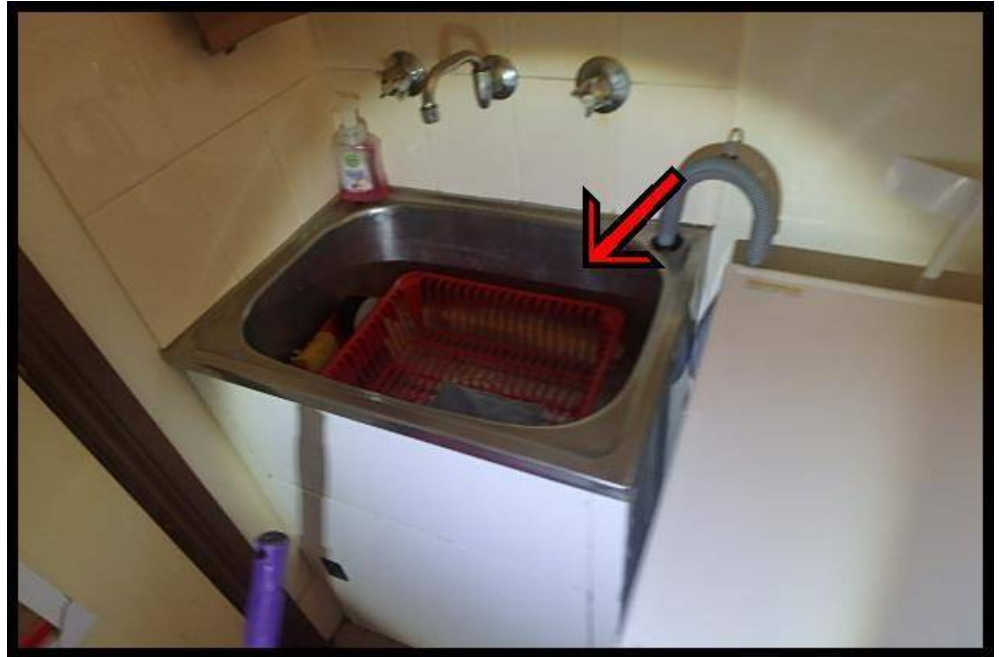
Tub & Taps:

The tub and taps appear serviceable.

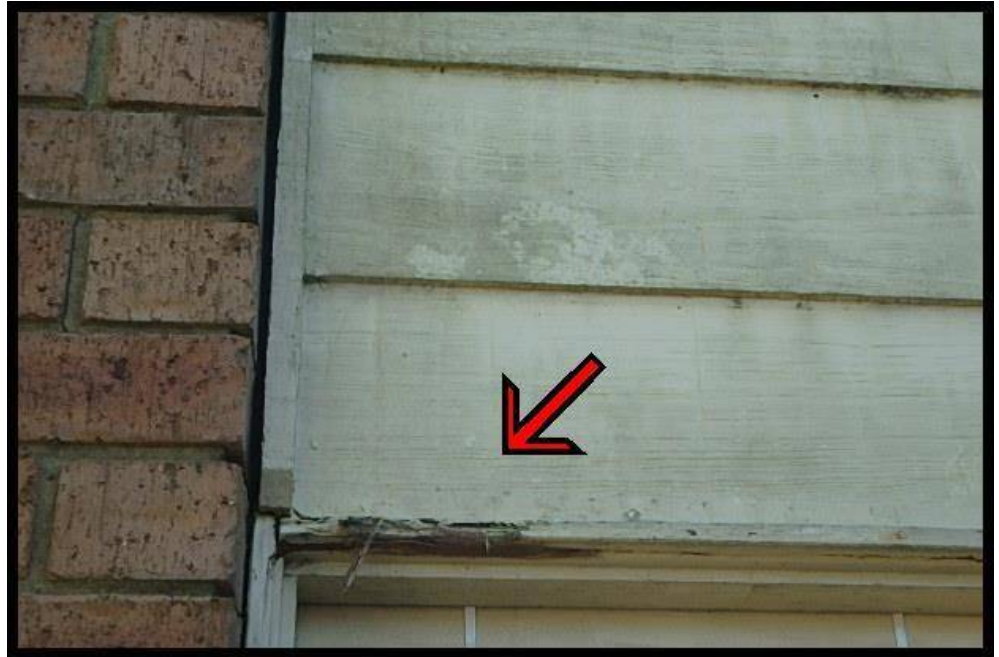
General Condition:

The condition of the walls is generally fair. Paint deterioration was present to external surfaces. Maintenance and/or repairs will be required.

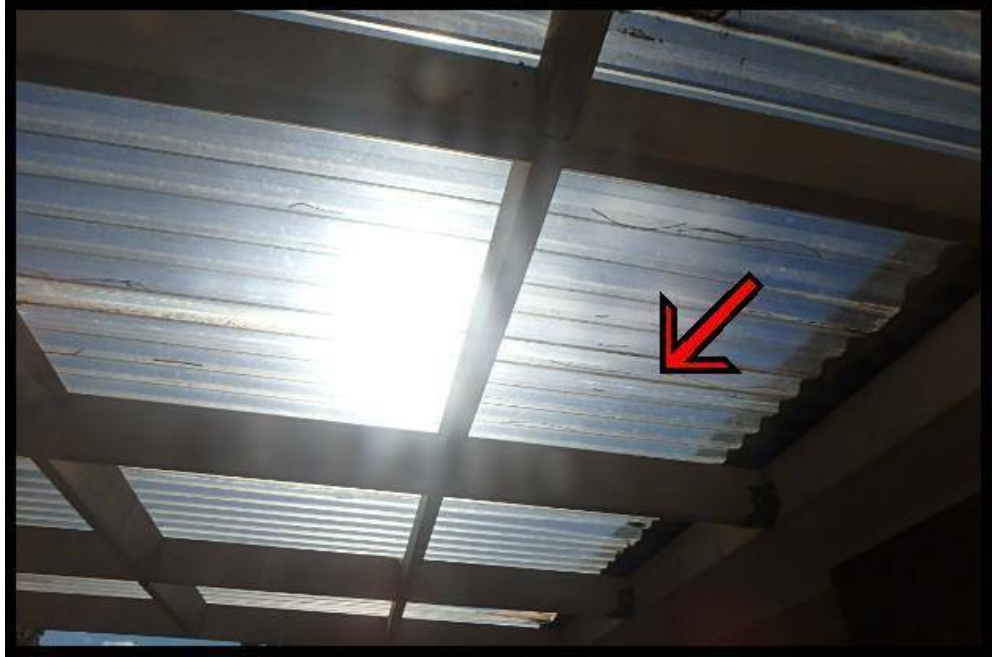
**Roof Covering Condition
Detail:**

The overall condition of the roof coverings is fair.

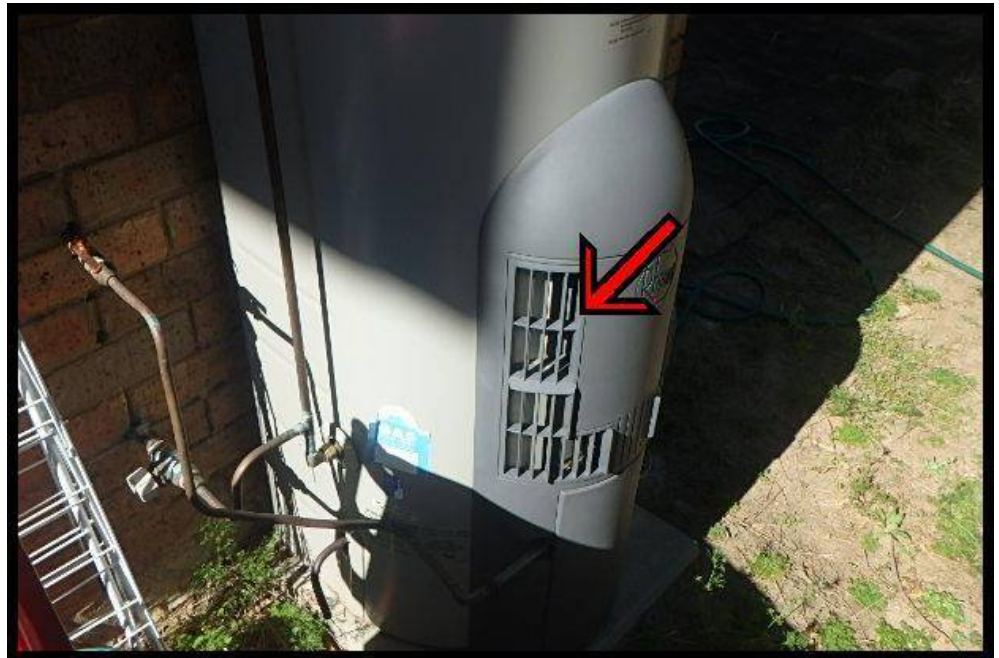
Hot water is provided by the following:

Gas hot water system: Mains pressure: Located externally: The hot water system appears to be in working condition. No specific tests other than running the hot water from a tap was carried out. No determination has been made as to the suitability or adequacy of the hot water system in relation to capacity or otherwise.
