Pest & Building Report

89 Paradise Drive Sampletown

Sample 2 Storey House

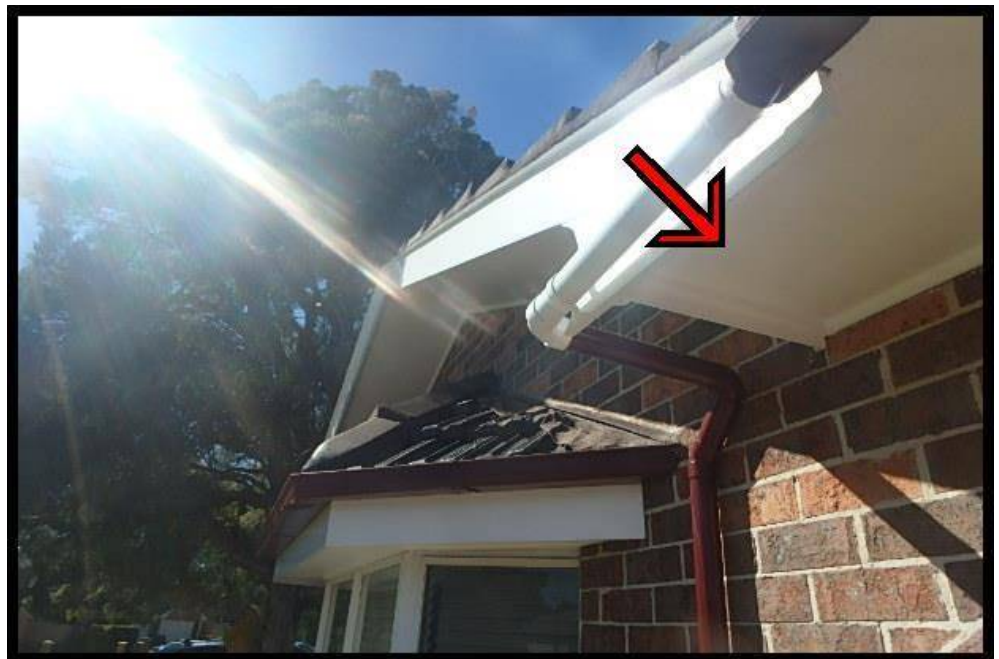
The eaves are lined with fibre cement sheeting. The overall condition of the eaves lining is good.

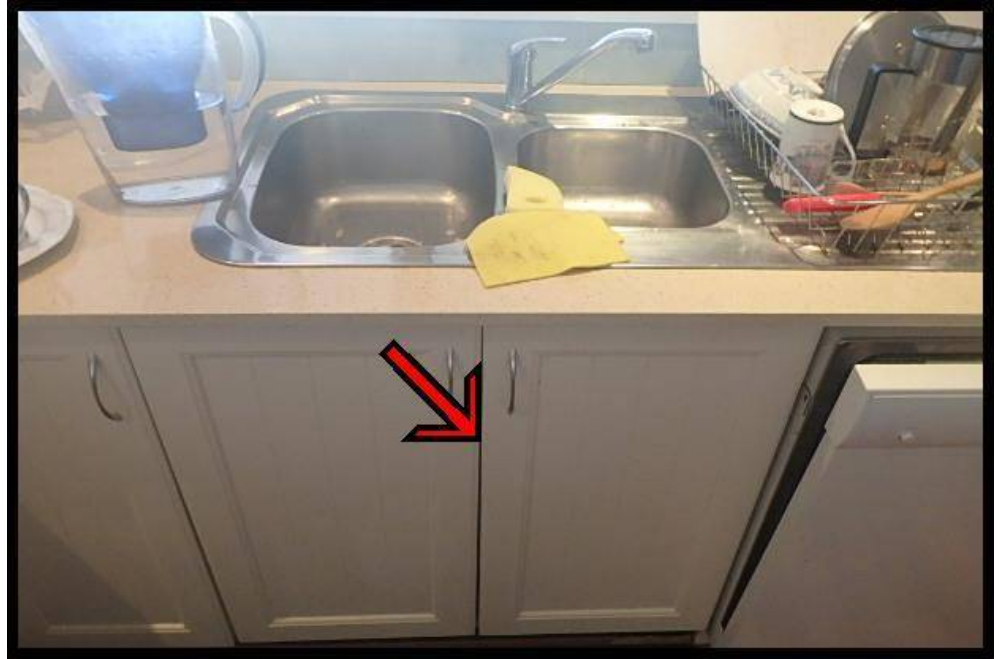
The condition of the fixtures is generally good. Adjustment is required to some door and drawers to ensure smooth operation. Wear and tear is noted to cabinets and/or doors and some maintenance or repairs will be required.

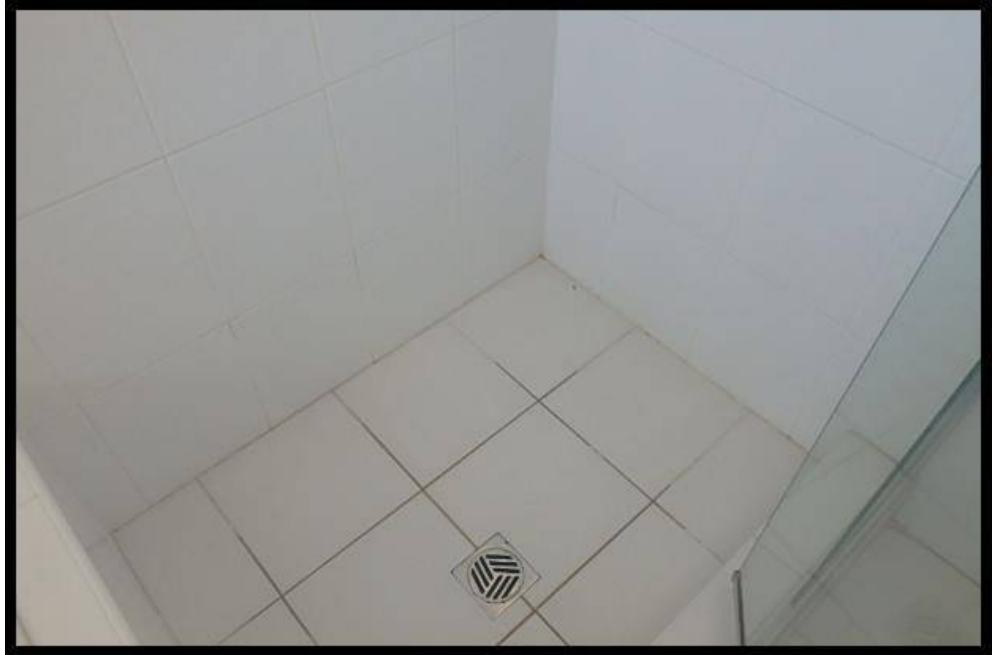
The shower recess was tested and there was no visible water penetration to surrounding areas. The waterproofing on the shower is out of warranty and we recommend the purchaser contact a shower waterproofing company to advise on further waterproofing & extended warranty options. IMPORTANT NOTE: This test may not reveal water leaks until the shower is put into constant use and surrounding areas monitored over a period of time.

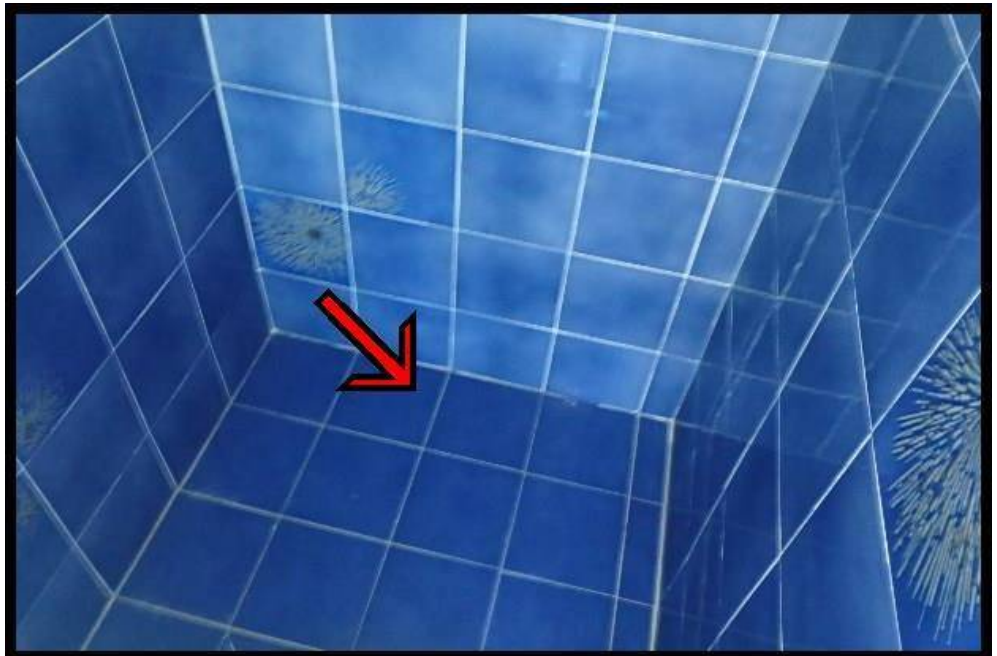
The shower recess was tested and there was no visible water penetration to surrounding areas. The waterproofing on the shower is out of warranty and we recommend the purchaser contact a shower waterproofing company to advise on further waterproofing & extended warranty options. IMPORTANT NOTE: This test may not reveal water leaks until the shower is put into constant use and surrounding

areas monitored over a period of time.

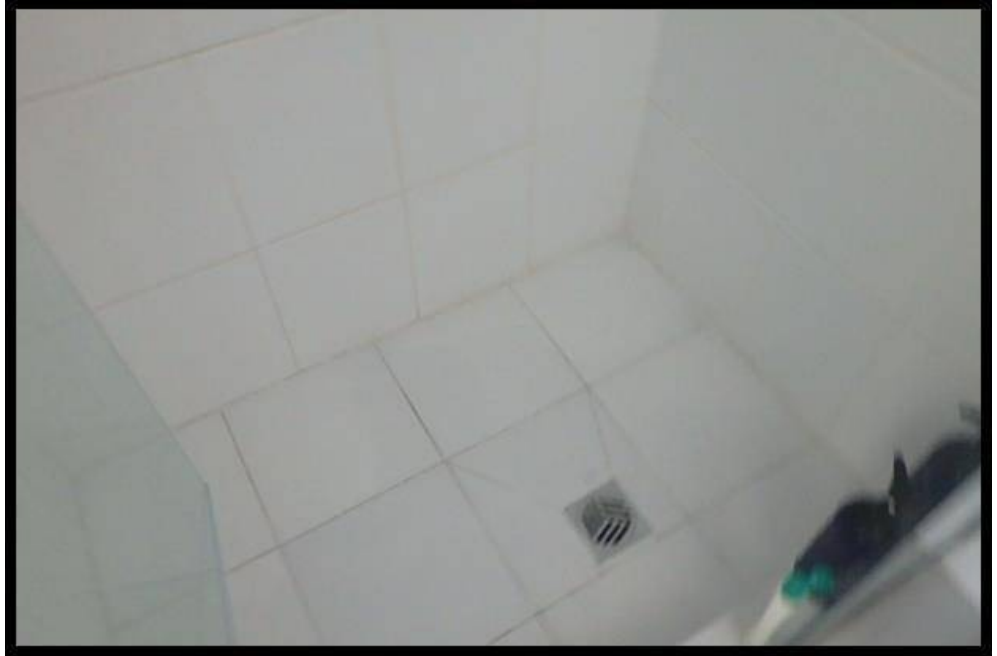
The shower recess was tested and there was no visible water penetration to surrounding areas. The purchaser should check with the vender that the shower recess is covered by the waterproofing company warranty. **IMPORTANT NOTE:** This test may not reveal water leaks until the shower is put into constant use and surrounding areas monitored over a period of time.

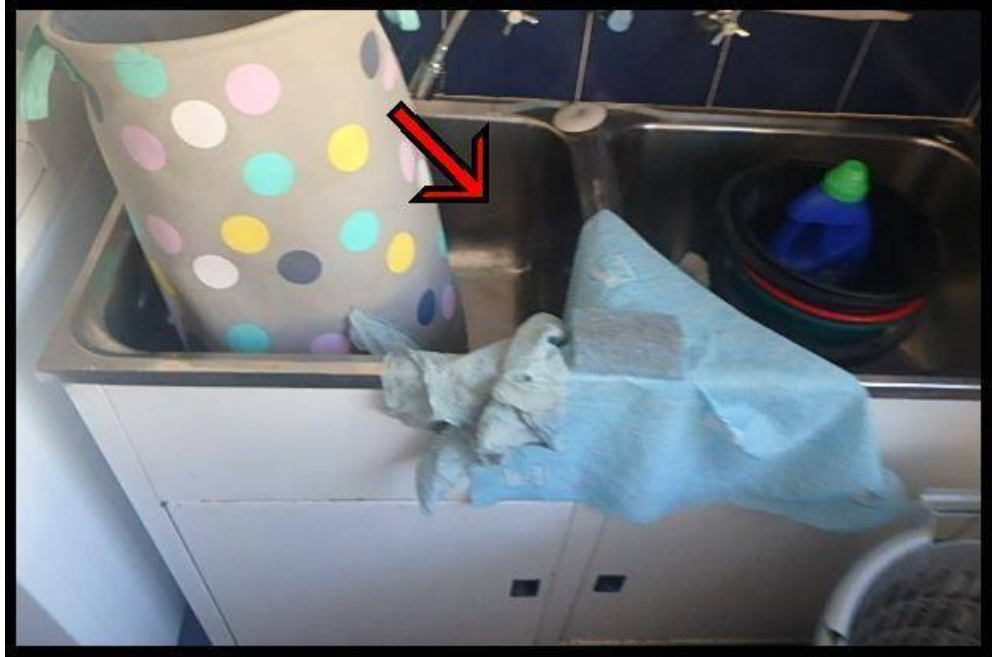
The tub & cabinet appear serviceable.

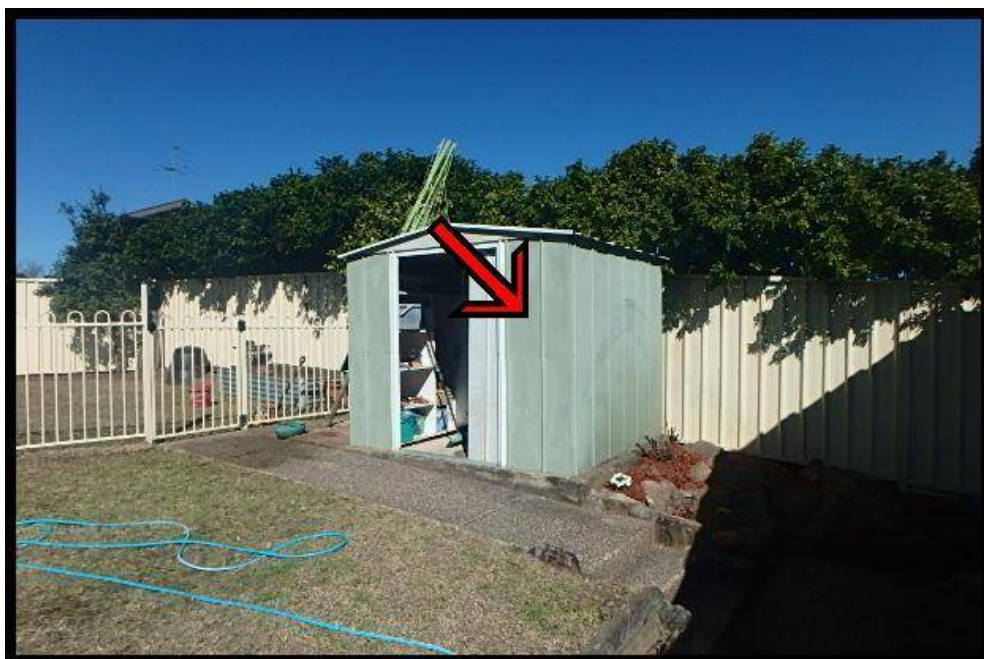
Metal garden shed:

Restrictions:	Inspection within some areas was restricted by stored items.
General Condition:	The structure is generally in good condition.

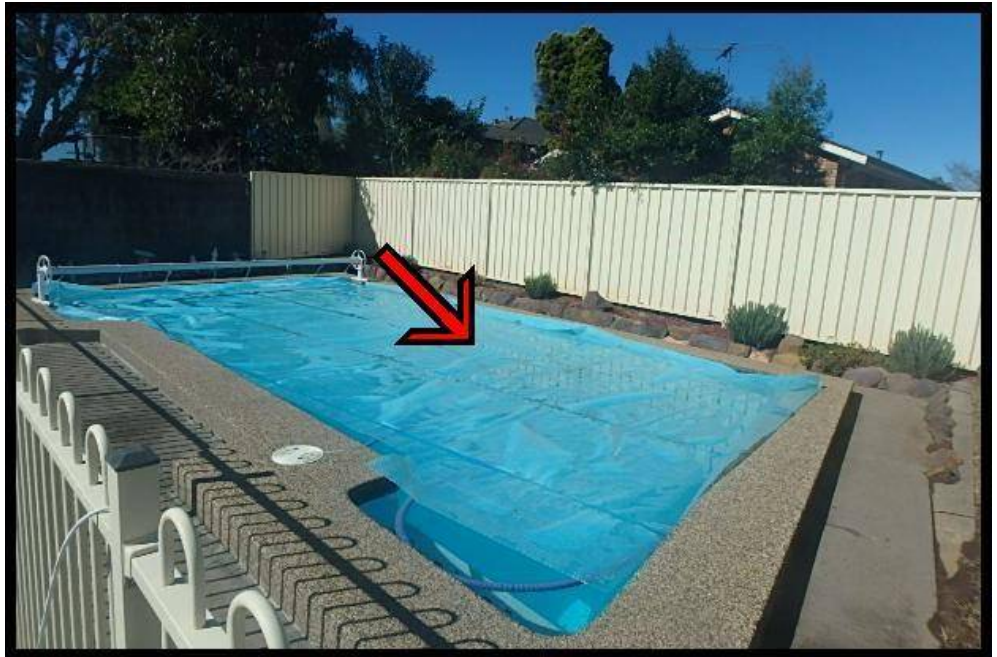
A swimming pool is present. This inspection specifically excludes any inspection of the pool, associated pool equipment and pool surrounds. An inspection should be made by a specialist pool inspector to determine the condition of the pool, pool equipment and surrounds.

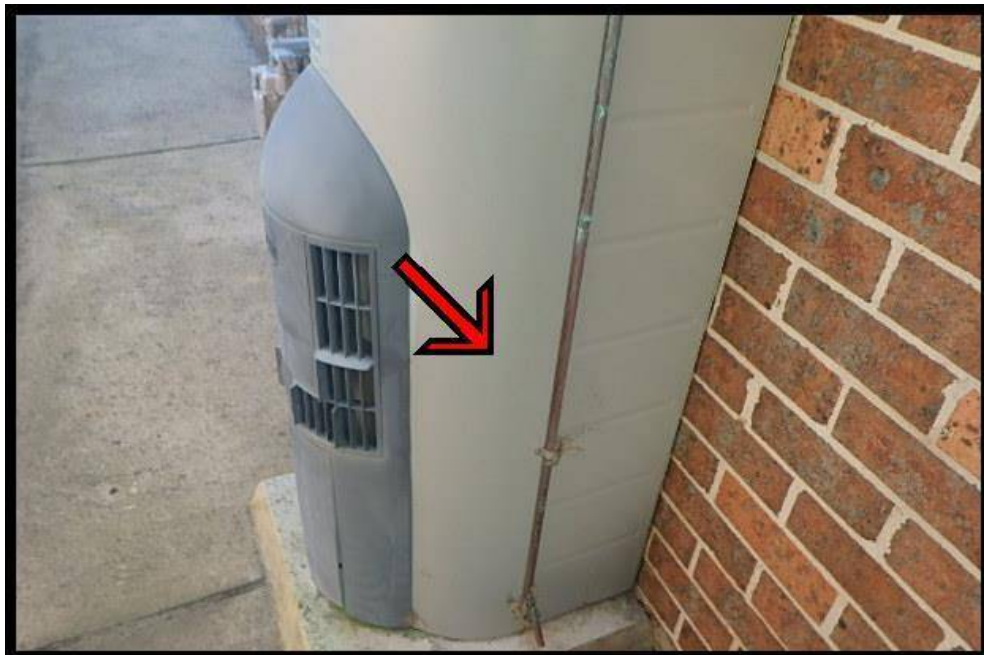
Gas hot water system: Mains pressure: Located externally: The hot water system appears to be in working condition. No specific tests other than running the hot water from a tap was carried out. No determination has been made as to the suitability or adequacy of the hot water system in relation to capacity or otherwise.
