Pest & Building Report

18 Majestic Street Airport

Sample 2 storey terrace

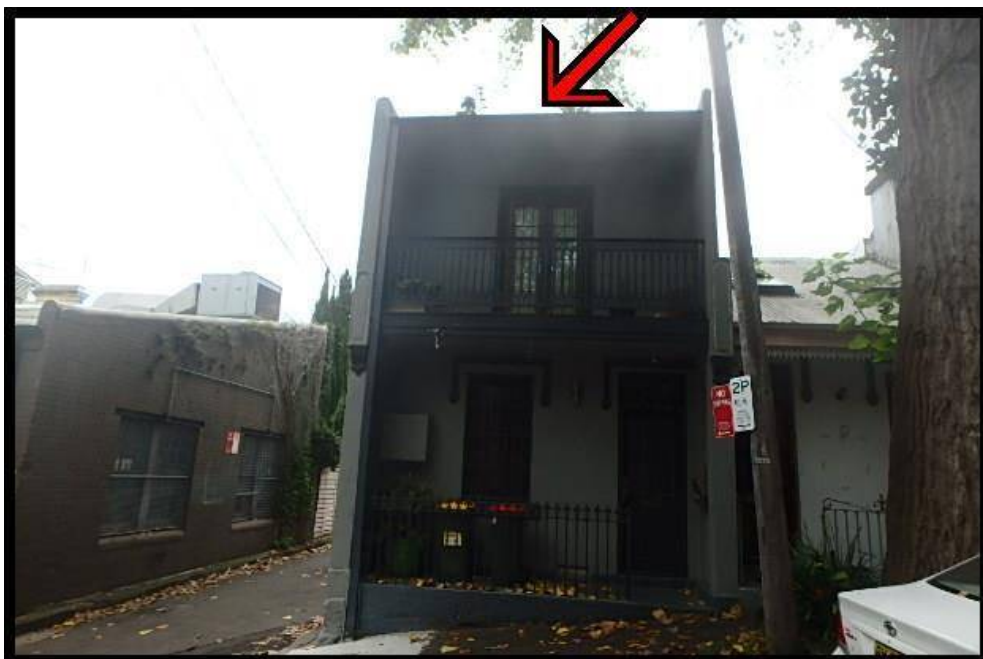
Roof Covering Condition in Detail:

The overall condition of the roof coverings could not be determined due to problems with access.

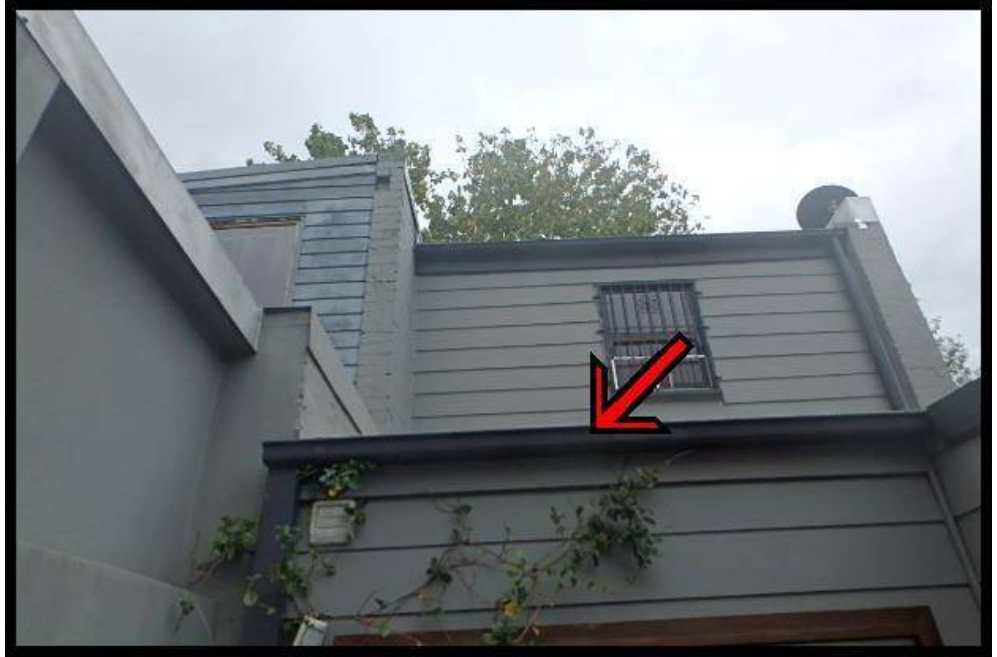
Gutters & Downpipes:

Leaves and debris are present in gutters. These should be cleared.

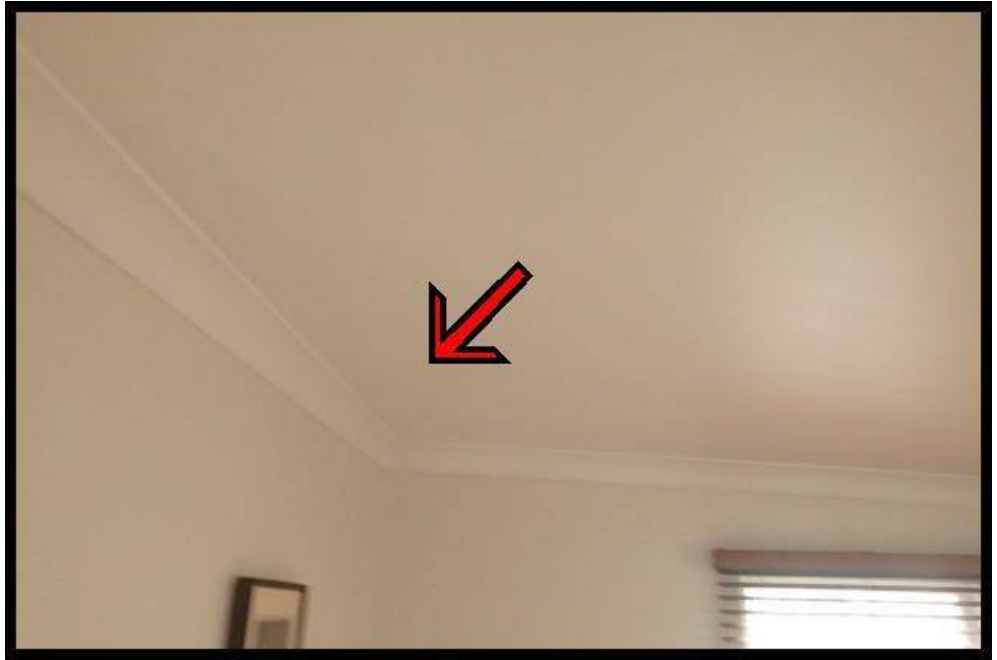
Ceiling Condition:

The condition of the ceilings is generally fair. Some minor blemishes were present on the ceiling linings. Ceiling height to the area listed may be too low and check should be made as to the compliance with the relevant standards.

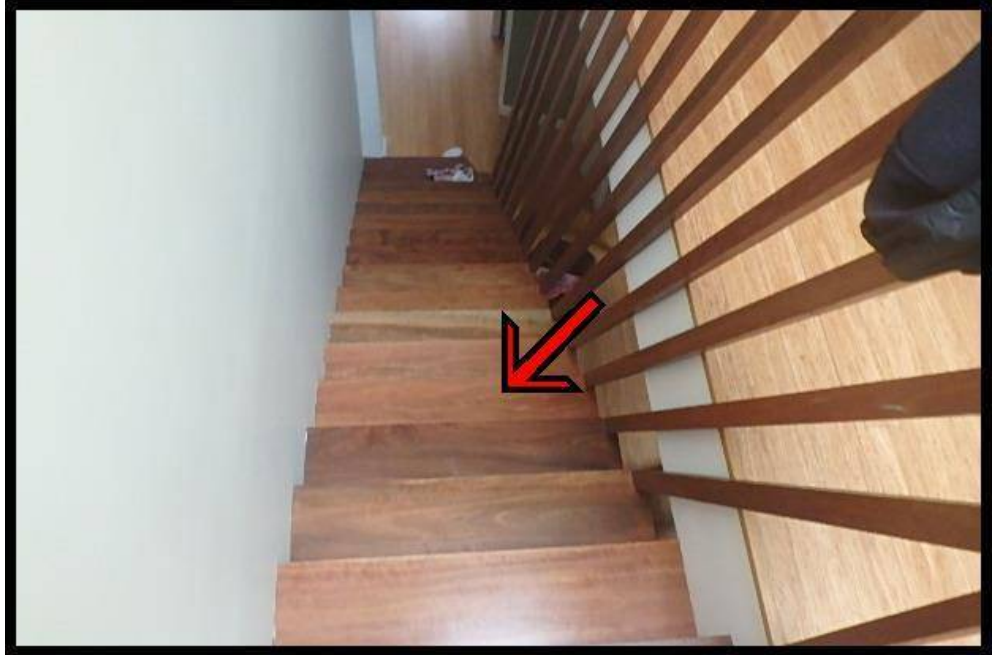
Type & Condition:

The stairs are constructed primarily from timber. The overall condition of the stairs is good.

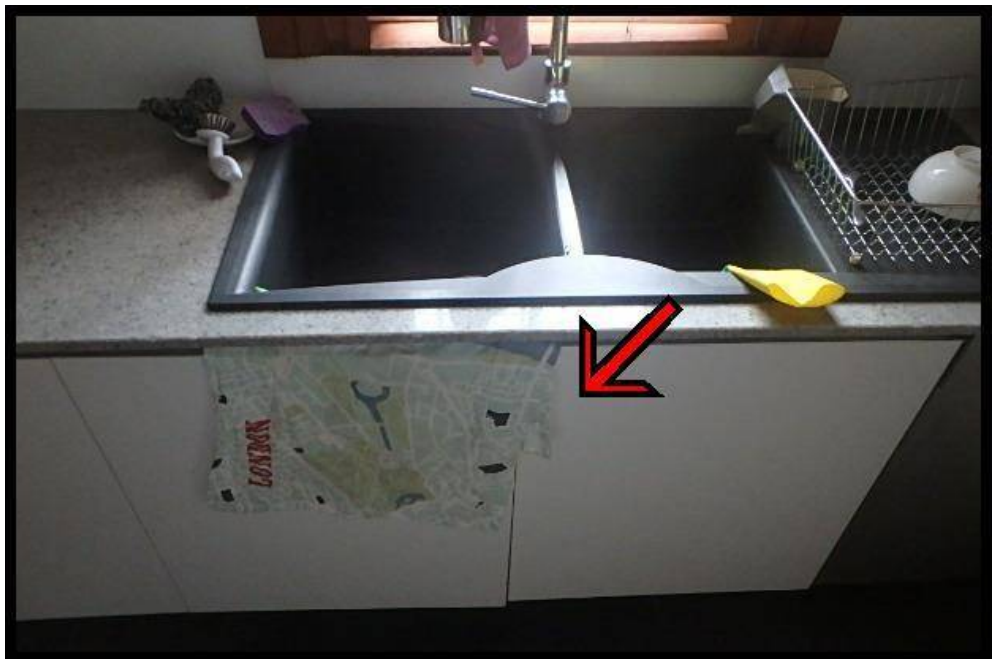
Kitchen Fixtures:

The condition of the fixtures is generally good. Adjustment is required to some door and drawers to ensure smooth operation.

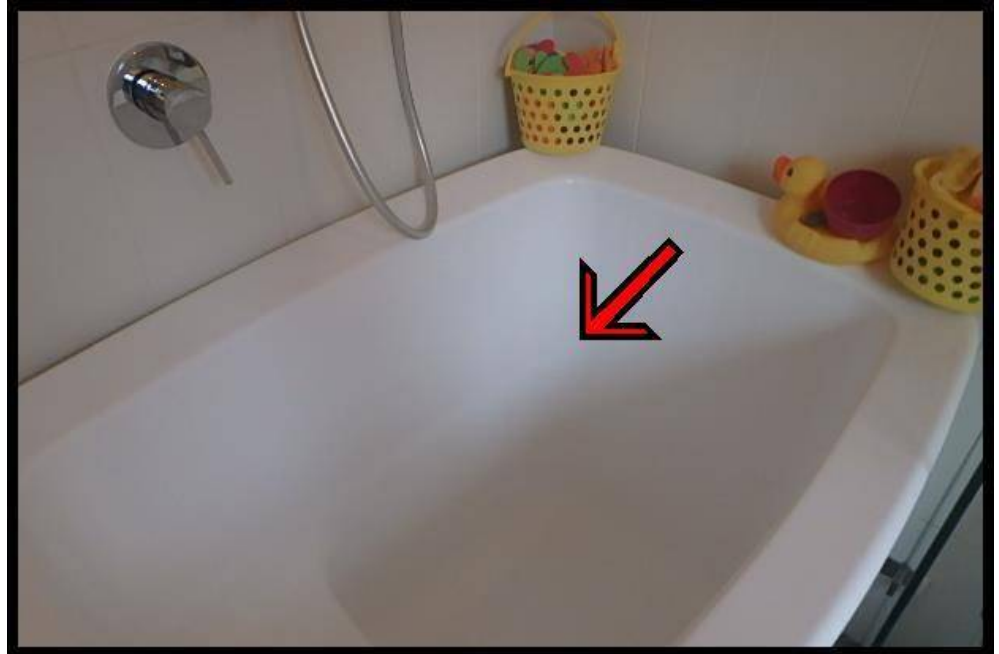
Shower/Bath Condition:

The shower is located over the bathtub. The area will need to be kept well sealed to prevent water penetration to surrounding areas.

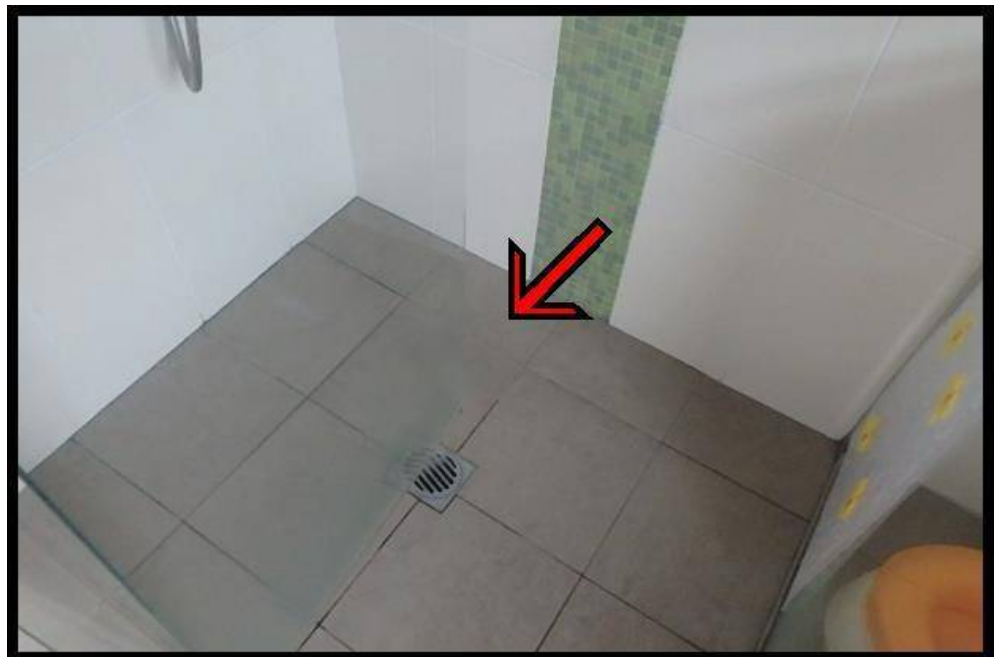
Shower/Bath Condition:

The shower recess was tested and there was no visible water penetration to

surrounding areas. The waterproofing on the shower is out of warranty and we recommend the purchaser contact a shower waterproofing company to advise on further waterproofing & extended warranty options. **IMPORTANT NOTE:** This test may not reveal water leaks until the shower is put into constant use and surrounding areas monitored over a period of time.

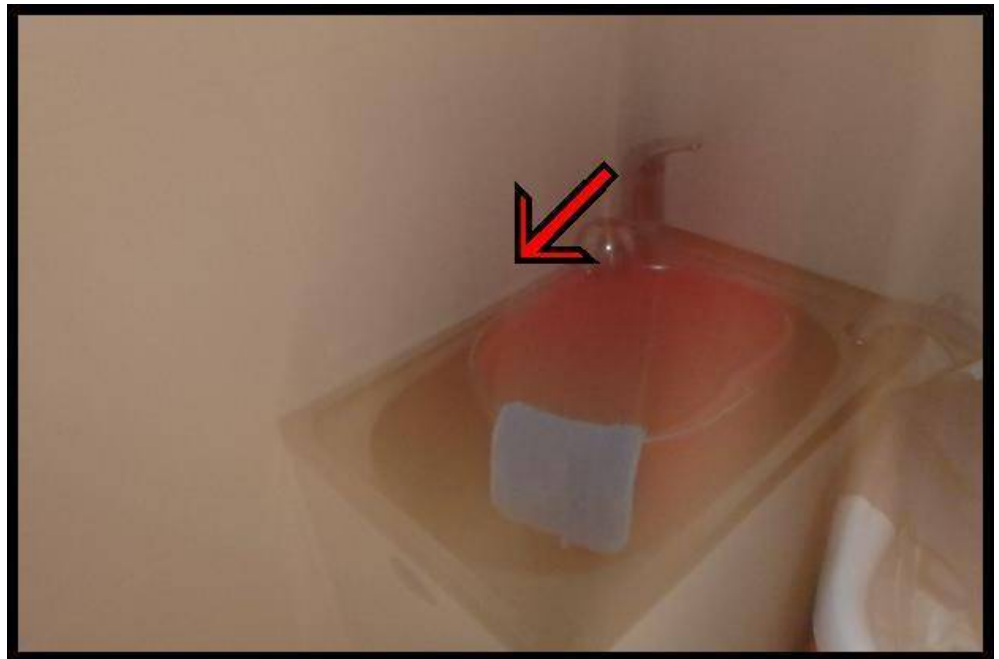
Tub & Taps:

The tub and taps appear serviceable. A tile splash back is not present and should be fitted.

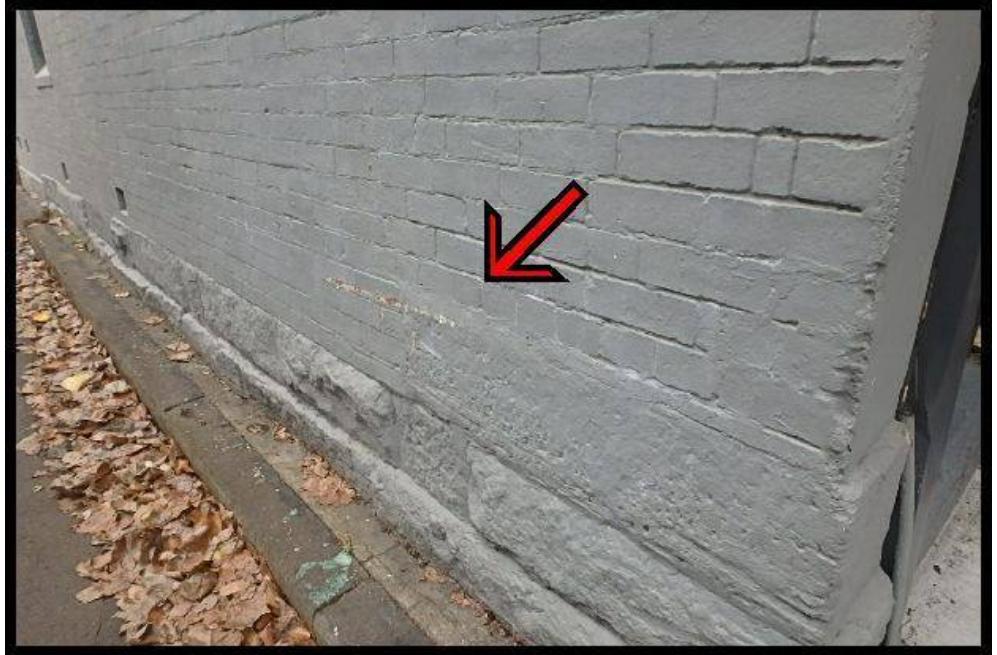
General Condition:

The condition of the walls is generally fair. The mortar joints between brickwork is deteriorating and needs re pointing in areas.

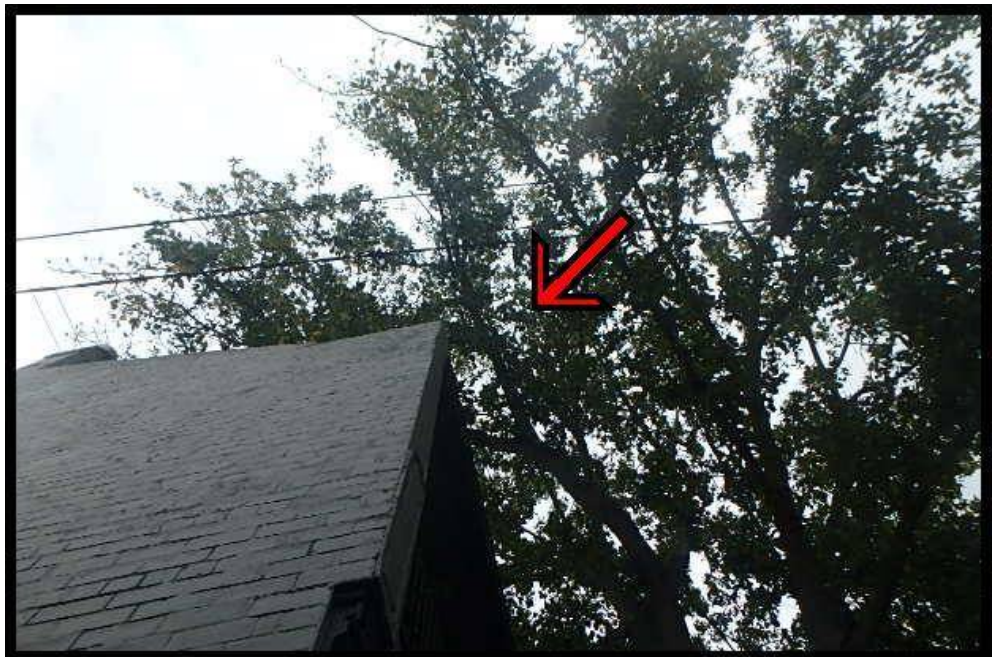
Issue and Location

Trees are located close to the building with tree limbs over the roof area. Consideration should be given to the cutting back of tree limbs over roof areas by a professional contractor.

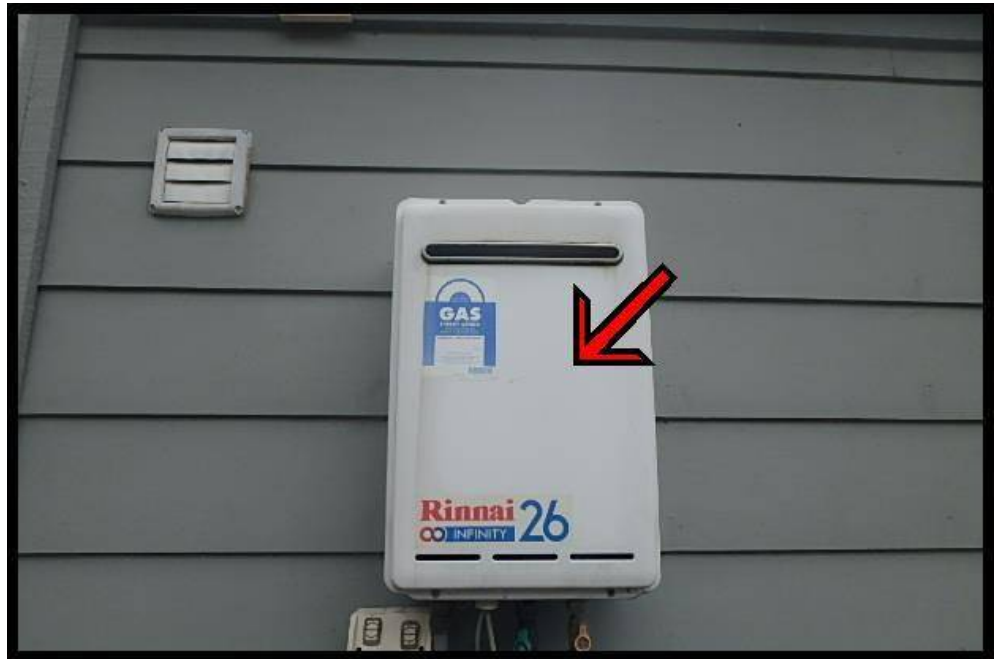
Hot water is provided by the following:

Gas hot water system: Instantaneous: Located externally: The hot water system appears to be in working condition. No specific tests other than running the hot water from a tap was carried out. No determination has been made as to the suitability or adequacy of the hot water system in relation to capacity or otherwise.
