# Pest & Building Report

**21 Sample Street Sample Town**

Sample Single Storey Brick Veneer House

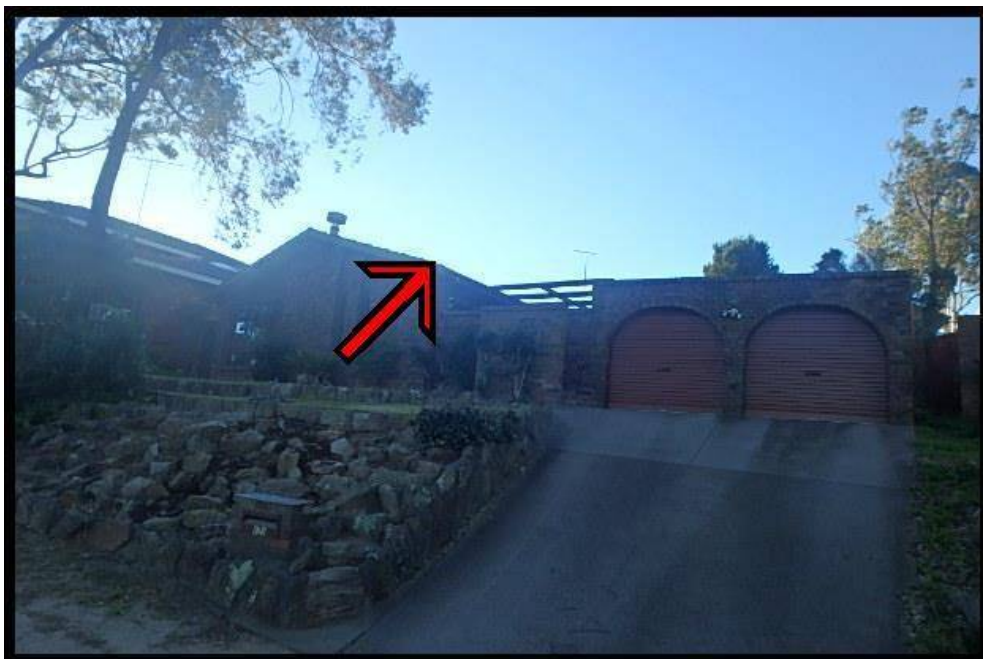
The overall condition of the roof coverings is fair. The surface of the concrete tiles is deteriorating and the area requires sealing.

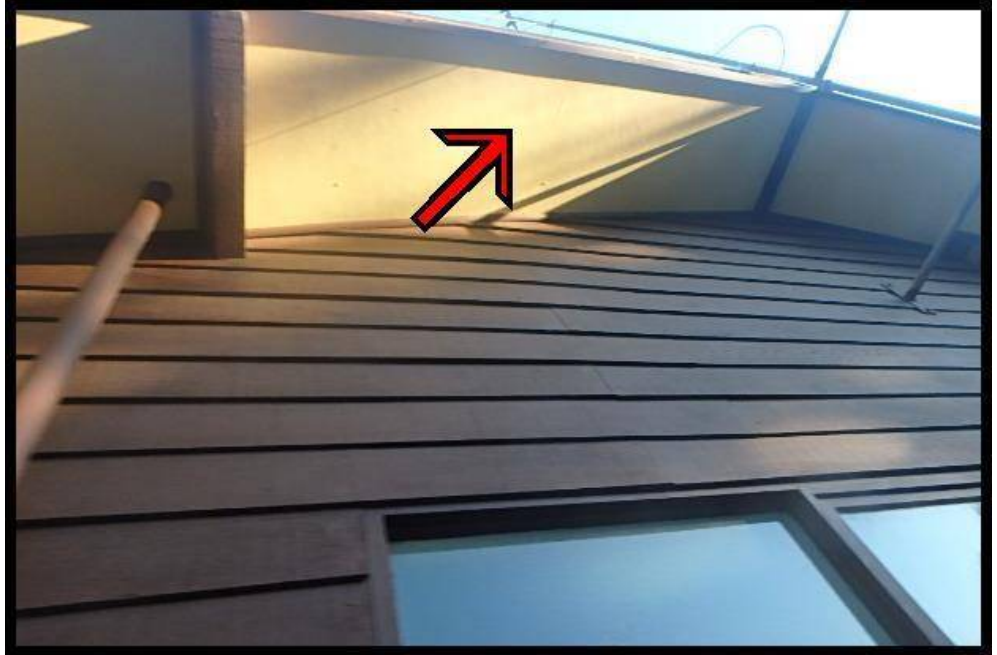
The eaves are lined with fibre cement sheeting. The paint work to the eaves is deteriorating and maintenance is required.

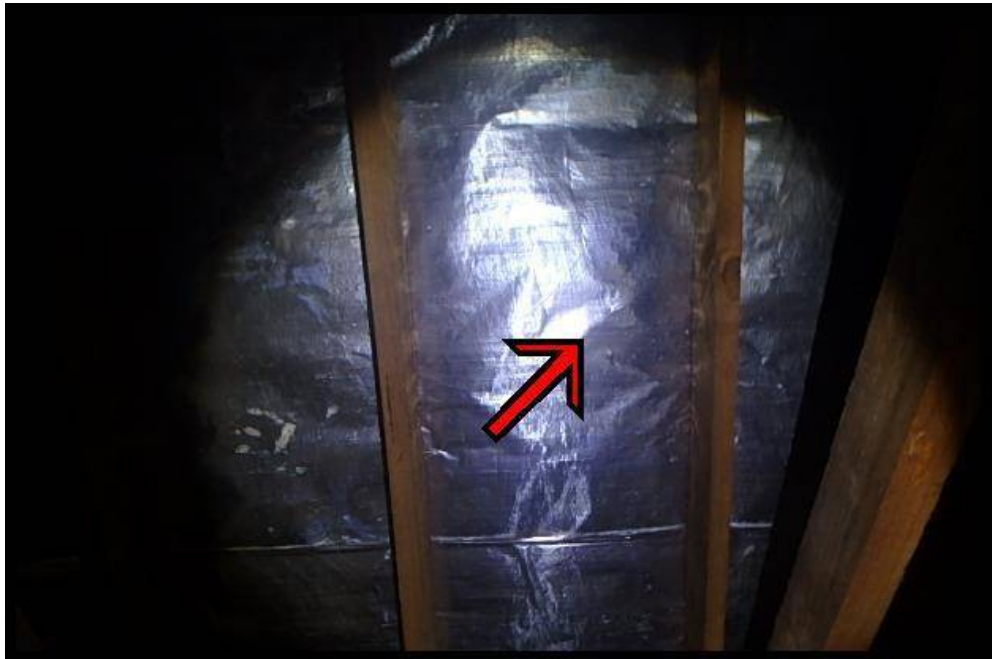
Inspection over the eaves was restricted due to the low pitch and construction allowing only a limited visual inspection from a distance to be carried out.

Sarking paper covered tile battens restricting inspection.

Ducting associated with air-conditioning or heating restricted inspection.

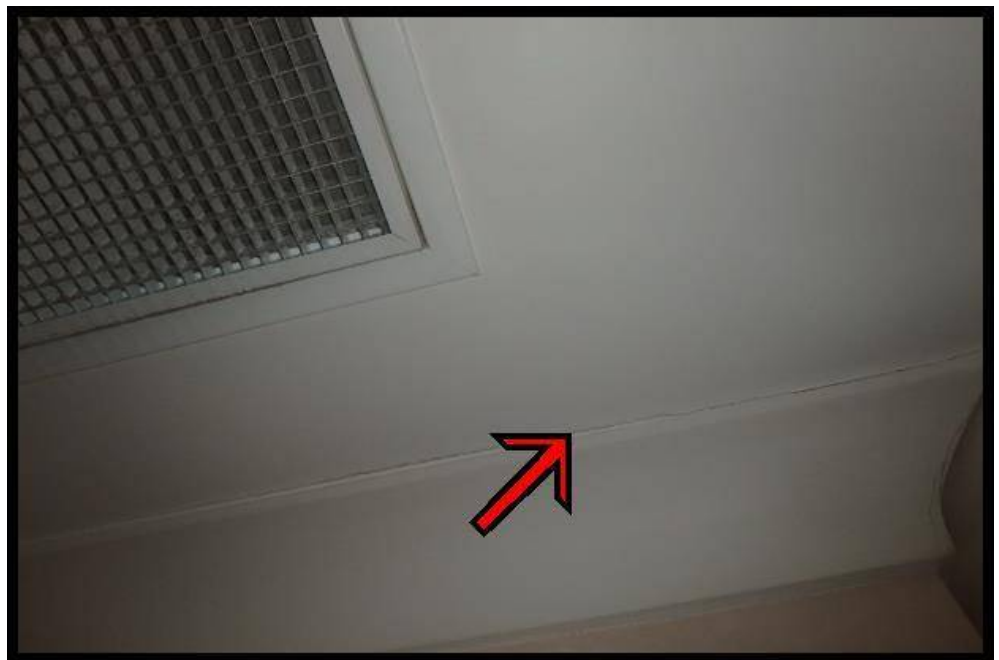
**Location/area** Various internal areas.

The condition of the ceilings is generally good. Some minor blemishes were present on the ceiling linings.

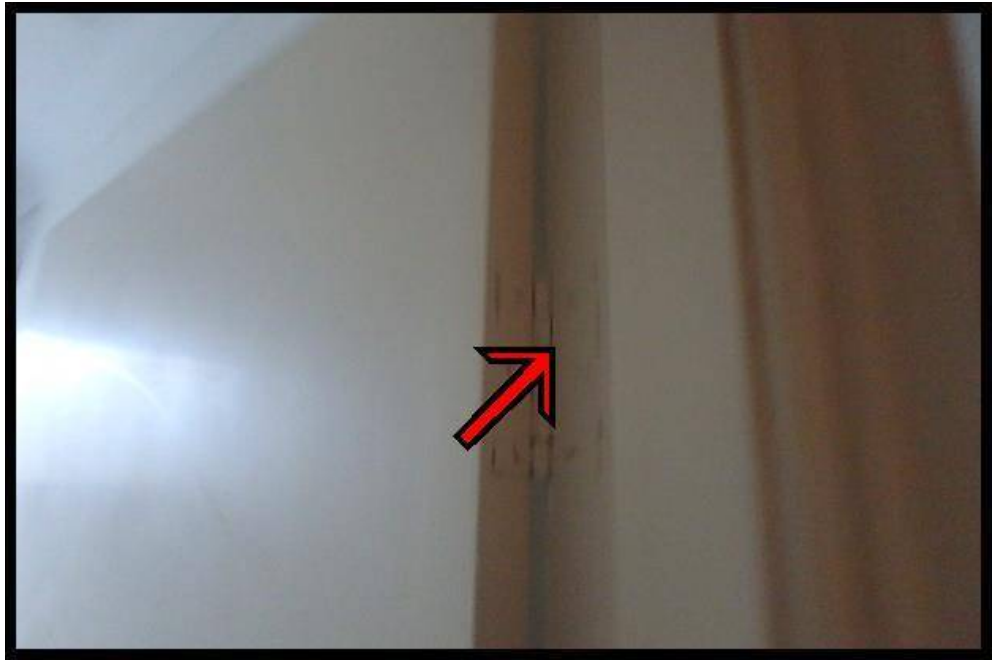
The condition of the doors is generally good. The toilet door swings inwards and is restrictive to the toilet area.

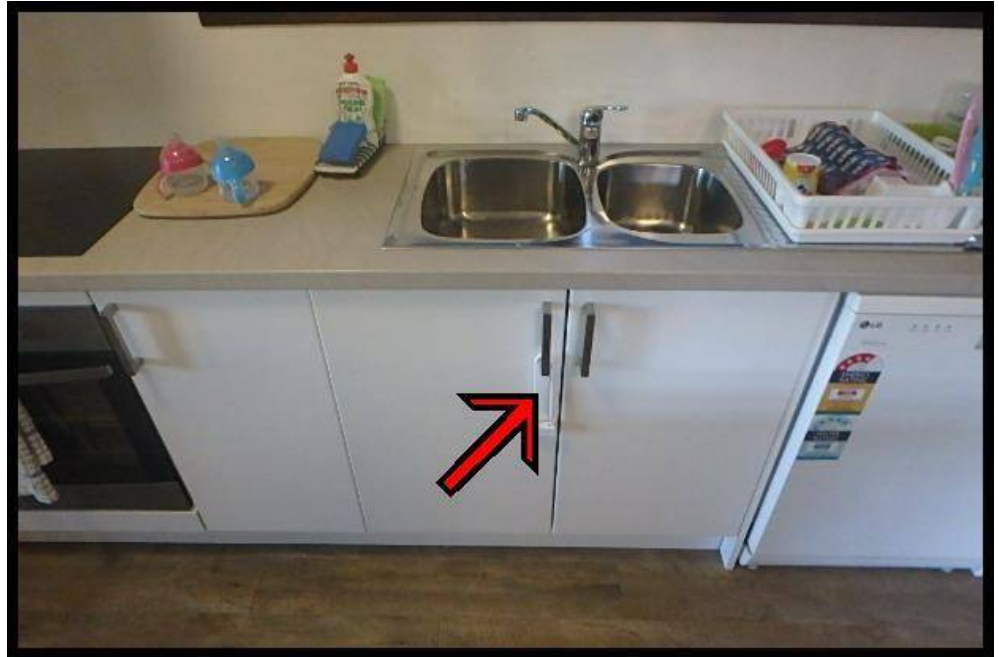
The condition of the fixtures is generally good. Wear and tear is noted to cabinets and/or doors and some maintenance or repairs will be required.

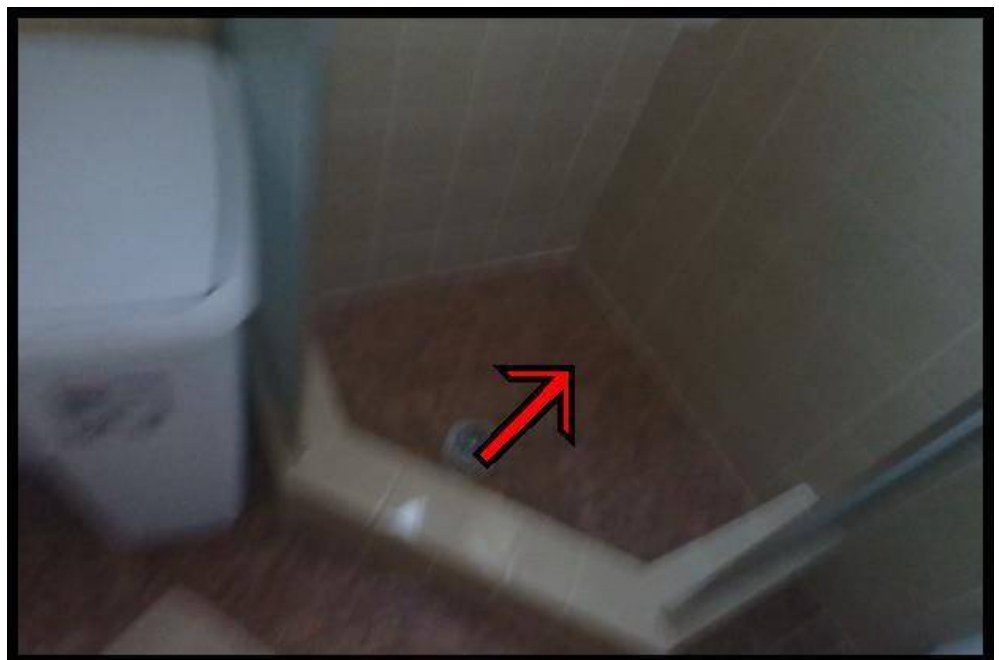
The shower recess was tested and there was no visible water penetration to surrounding areas. The waterproofing on the shower is out of warranty and we recommend the purchaser contact a shower waterproofing company to advise on

further waterproofing & extended warranty options. **IMPORTANT NOTE:** This test may not reveal water leaks until the shower is put into constant use and surrounding areas monitored over a period of time. Silicone sealant has been applied to the interface of the floor and walls in the shower recess in an apparent attempt to prevent water penetration to surrounding areas. This method of repair can only be considered to be temporary. Further waterproofing may be necessary.

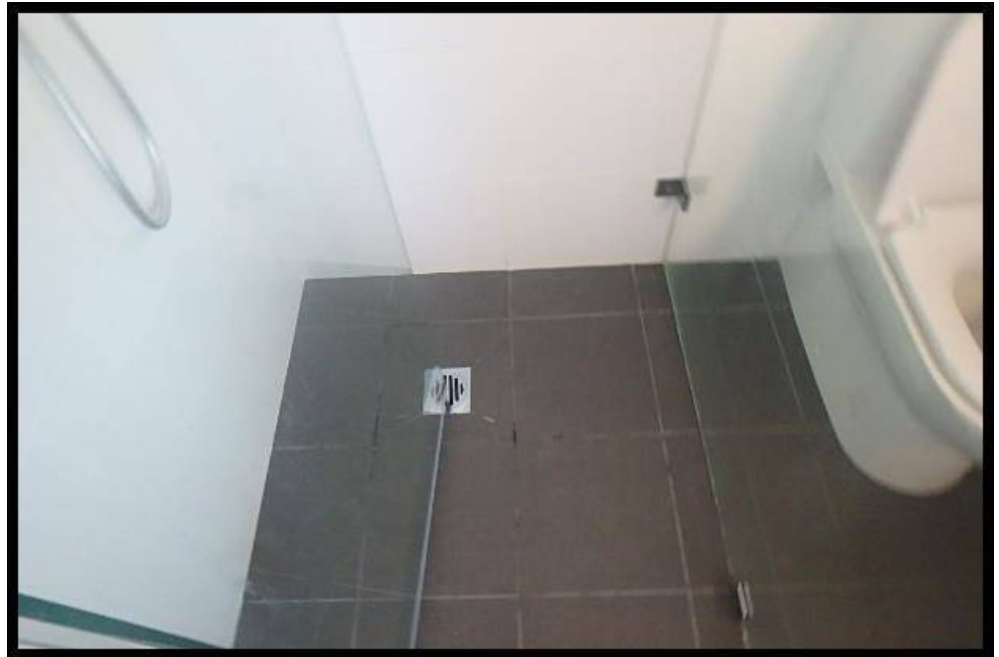
The shower recess was tested and there was no visible water penetration to surrounding areas. The purchaser should check with the vender that the shower recess is covered by the waterproofing company warranty. **IMPORTANT NOTE:** This test may not reveal water leaks until the shower is put into constant use and surrounding areas monitored over a period of time.

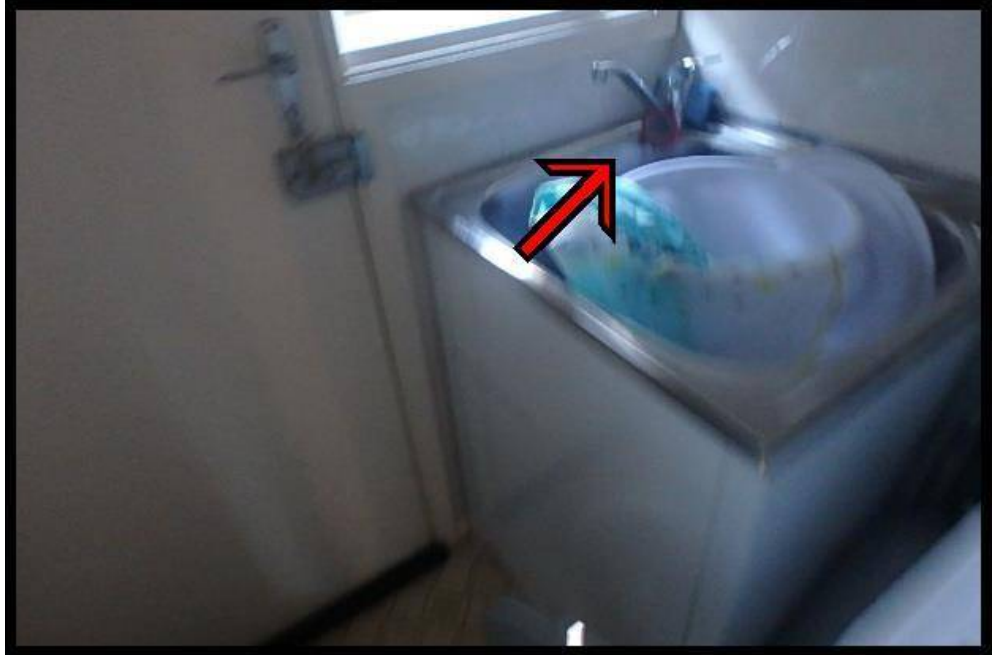
This area is generally in good condition.

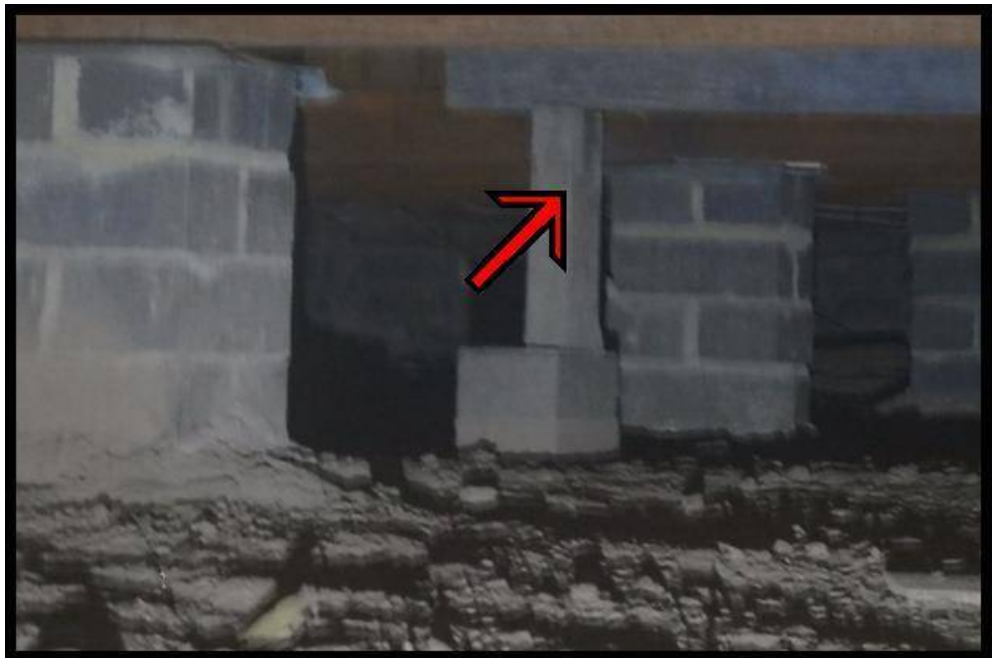
Timber floor supports are located to the sub floor of the building. These should be replaced with brick piers or steel supports.
